# **Aquatic Plant Survey Report Big Pine Lake (Aitkin Co.)**

Point-Intercept Method

July 18, 2021

DOW# 01015700

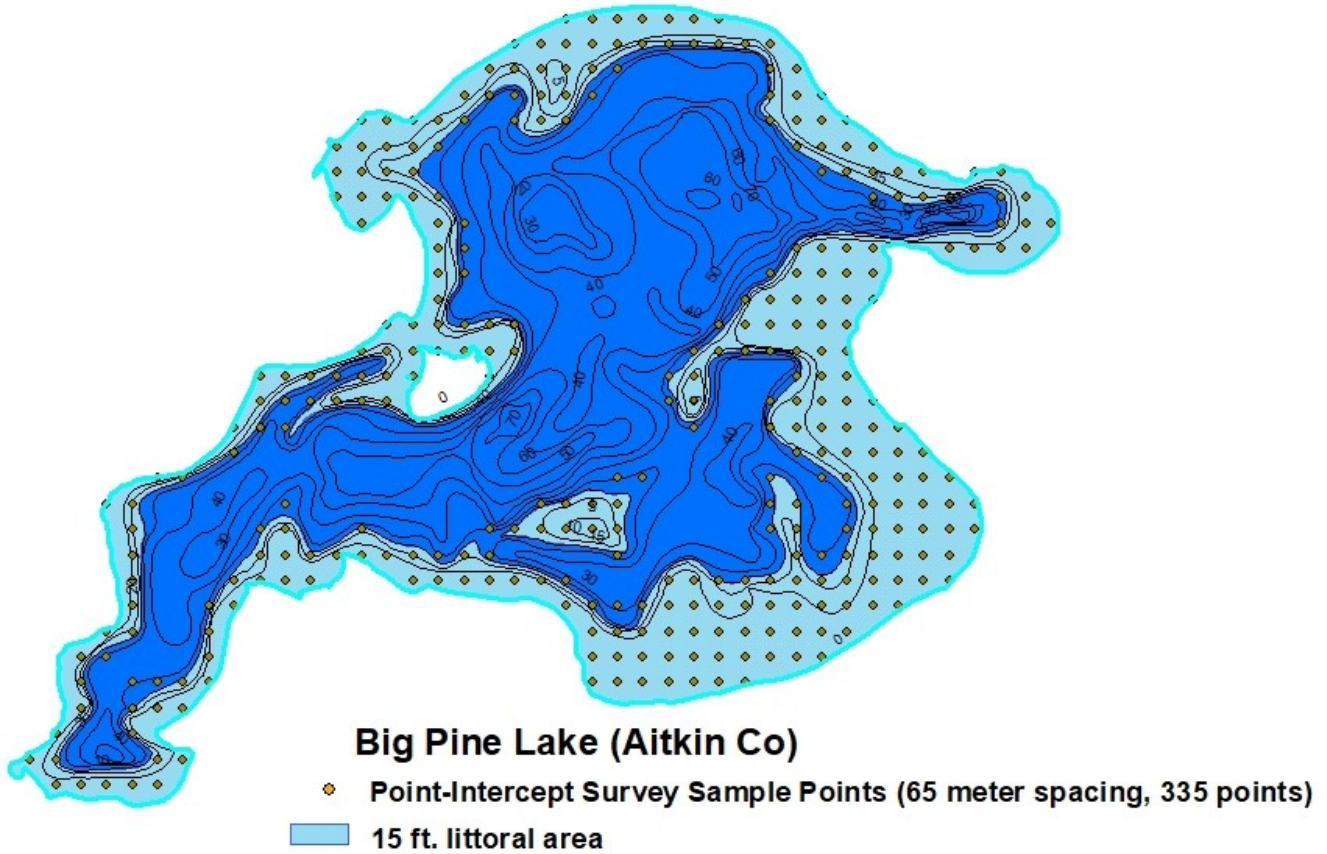
**Figure 1. Big Pine Lake Point-Intercept Survey Grid, 65 meter spacing (335 sample points)**

Sample points were created in ArcGIS and spaced 65 meters apart across the lake. We then uploaded bathymetric contours for the lake from the Minnesota Geospatial Commons and overlaid the sample points. Waypoints that appeared deeper than 30 feet were then deleted, leaving a total of 335 sample points. These sample points were then uploaded to a GPS unit and used to navigate to each sample point in the field. If points were inaccessible due to shallow depth or dense emergent vegetation, it was noted and the point was skipped.

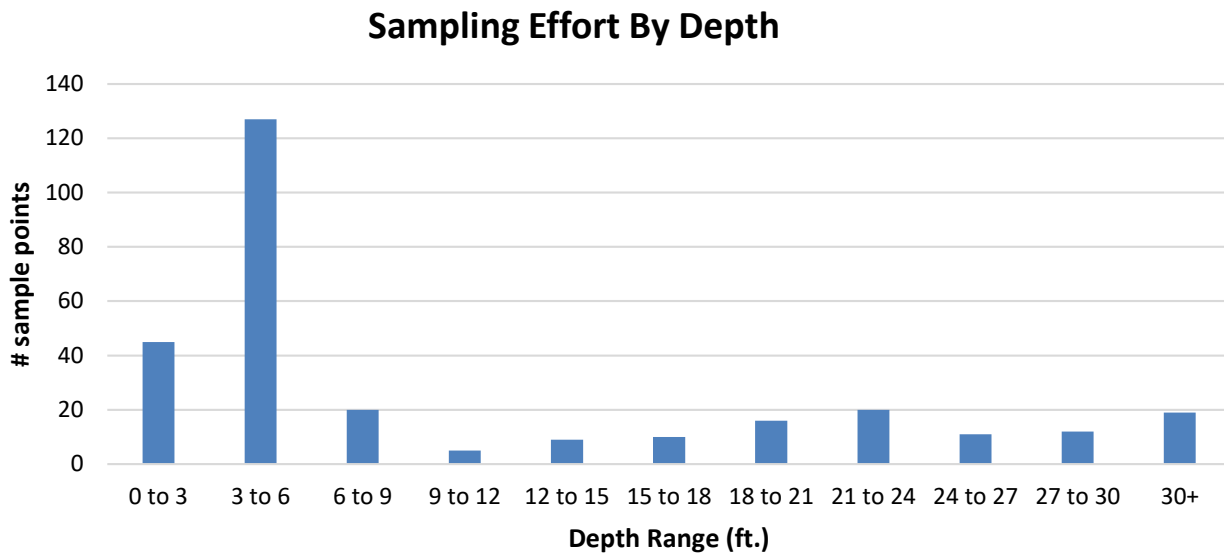
**Figure 2. Number of sample points by depth range**

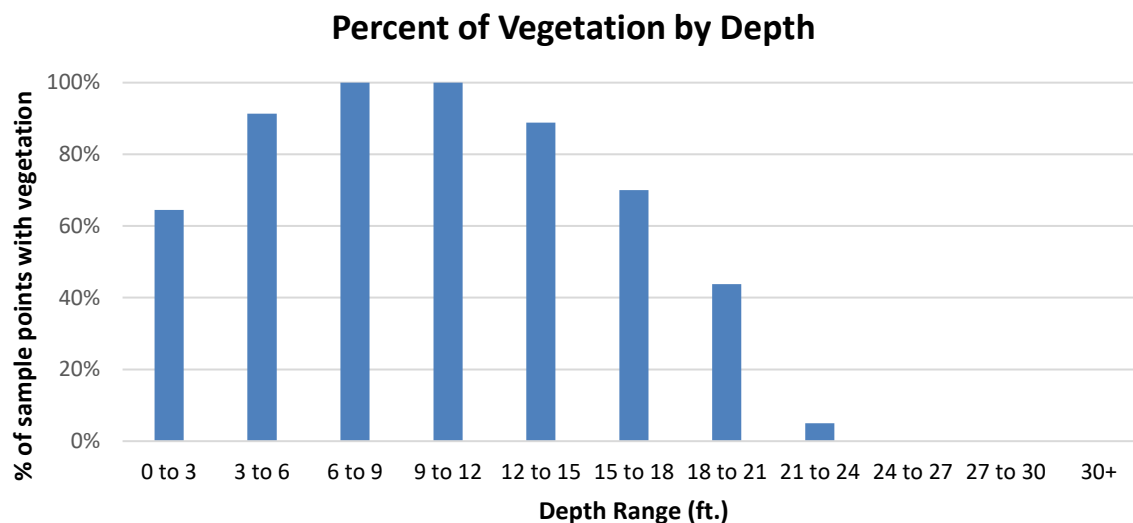
**Figure 4. Percent of sample points with vegetation by depth range**

Aquatic plants were found growing out to a depth of 22 feet. Frequency of occurrence for each species was calculated off of both the legal definition of littoral area, which is up to 15 feet of water, and the actual observed littoral during the survey which is the depth zone where aquatic plants were found growing, which is 22 feet.
